## Stratus Head Case

This diagnostic episode concerns a 2005 Dodge Stratus with a 2.4L engine (vin J) and an automatic transmission. The MIL is on, and a DTC P0491 (air injection system performance) has been stored. The car only has 39,000 miles on the odometer and is very clean. After checking for applicable TSBs, and finding none, I pulled the trouble code description to better understand how the code was recorded.

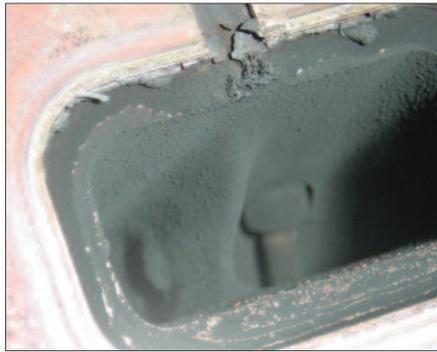
**W**hat's wrong with this picture? It may seem obvious now, but not so much with the engine assembled.

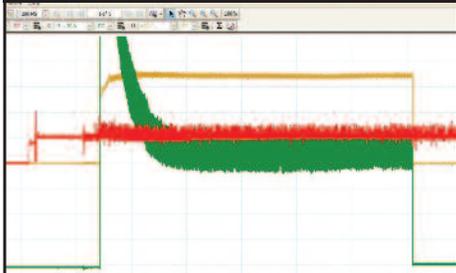
This first screen capture (Figure 1) was taken with the system connected as it should be. The gold trace shows the PCM is indeed sending the power to the relay, and the pump current pattern shows the relay is engaged and the pump is running. MAF increased only slightly, however, to just under 1.0 volt.

Could the MAF be reading incorrectly, or is it possible the correct reading wasn't reaching the ECM? Could it be a restriction to airflow in the plumbing?

**Figure 1:** The gold trace indicates the PCM is sending power to the relay. The pump current pattern indicates the relay is engaged and the pump is running. MAF increased only slightly, to under 1.0 volt.

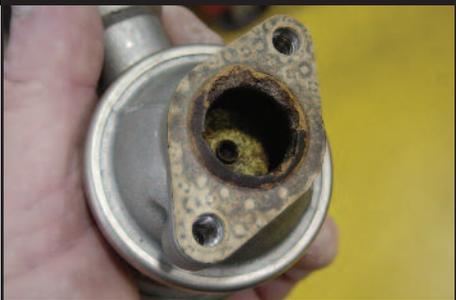
I removed the one-way valve for a visual inspection. How did the valve get so corroded (Figure 2)? And why is the current flow on the motor higher with the restriction removed? While there is no specification, 34 amps had to be too much. The car was "new" to our customer, but I suspect water had intruded into the pump somewhere in this car's past. I shared my

**Figure 2:** How did this valve get so corroded? And why is the current flow on the motor higher with the restriction removed?

concerns with my boss, and she authorized replacement of the air pump and one-way valve.

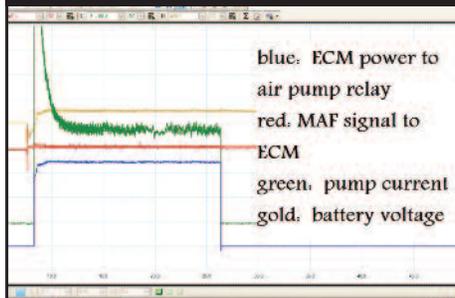
The one-way valve was replaced, along with the air pump (there was a severe current fluctuation in the original) and relay (as recommended by the manufacturer when the air pump is replaced). The screen capture in Figure 3 in the next column was taken after this repair.

This time, I added a channel to include battery voltage. This allowed me to identify the point on the capture when the key was turned on, the engine started, and then shut off again. The information shows all is working as it is supposed to, but still only 0.10 volt change in MAF with the pump running. It looks like there is still a restriction somewhere.

**Figure 3:** The magnetic reluctance CKP is producing a sine wave AC voltage pattern, but noise in the signal may indicate a problem with the sensor.

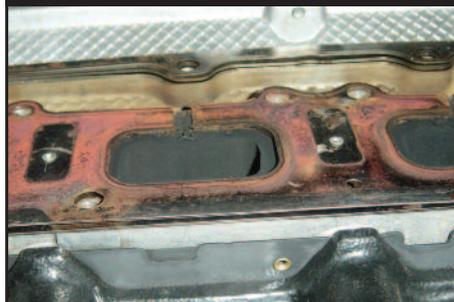
The ports were not clogged, because there were no ports to clog! Somewhere in this car's past, the cylinder head had been replaced with a Federal emissions head, and the ports were never drilled through. The tech who did the work was smart enough to know this wouldn't work, and double gasketed the exhaust manifold after cutting passages of his own in the gaskets themselves (Figure 4).

**Figure 4:** There were no air injection ports to clog. Double gaskets were used during a previous repair, with slots cut out where the ports should have been.

As you can see, the Federal head has no ports for the secondary air injection system (Figure 4), while the California head does (Figure 5). The Federal head does, however, have an EGR port that the California head does not. On this job, the previous tech had tried to thread the port and install a bolt to seal the hole.

Finishing this job took some doing. There isn't much demand for new cylinder heads for the California version of the 2.4L engine. Our dealer originally ordered a reman head for us but when it arrived it was a Federal-style head, just like the one I wanted to replace. The final solution was to order a brand new bare head casting and swap everything over.

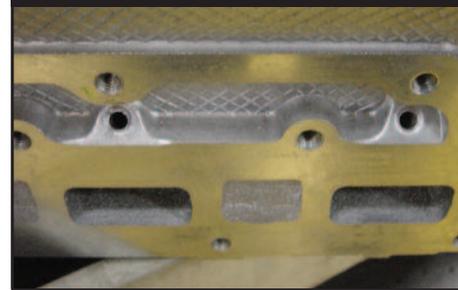
**Figure 5:** This photo of the California-spec cylinder head clearly shows the needed air injection ports. One of these heads isn't that easy to come by.

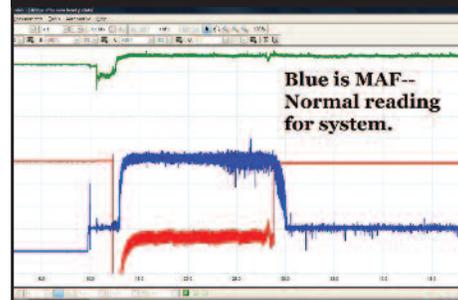
**Figure 6:** Running a scope test after completing the head replacement allowed me to verify the repair and also provide known-good patterns for future reference.

As a last step, I hooked up my scope to verify the repair (Figure 6). I only watched the motor current and MAF signal, since I'd already confirmed that the system was working. I wanted to know what a normal system would look like with no restrictions in case I ran into something like this again. Hope you enjoyed the tale! **WELLS**
