The Triangle Of Doom

The following challenge involves a 2001 Toyota Prius hybrid with 98K on the odometer. While driving, the owner noticed a warning light on the dash. The warning light was shaped like an exclamation point inside a red triangle. It looked serious, so the owner decided to take the vehicle to the Toyota dealer. The service adviser listened to the owner's complaints and checked the vehicle dash for the illuminated triangle. His next step was to write up the repair order (RO) and assign the shop's certified hybrid technician.

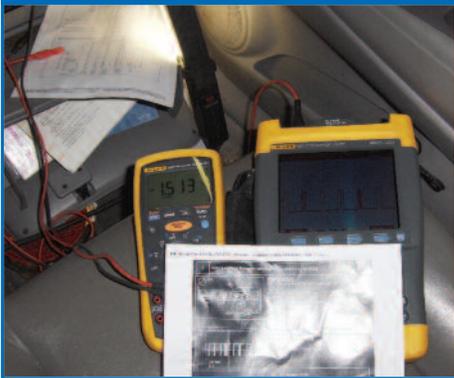
Figure 1: Checking voltage between HTE+ and HTE-

Following the Toyota flowchart and checking voltage between HTE + and HTE - of the ECM, I came up with a reading of 1.49 volts and a waveform that matched Toyota's example (Figure 1). The Toyota flowchart then states that the ECM should be replaced. I've been around awhile, and it's hard for me to swallow replacing an ECM without first checking every sensor and component that is associated with it. I think that flowcharts should be renamed "trouble charts" because in many cases that's what you will find yourself in.

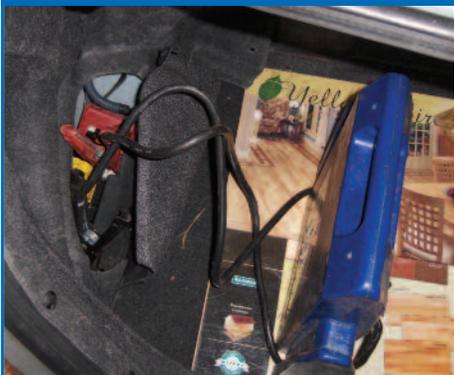
Figure 2: Installing battery pack on AGM battery

Since the flowchart did not make sense to me, I decided to get back to the basics and test the 12-volt battery. I found that the vehicle's absorbed glass mat (AGM) 12-volt battery was below specification. A word of caution is in order concerning this battery. Be careful when charging the AGM 12-volt battery because it can and will be damaged if the charging current surpasses 3.5 amps.

As you can see in Figure 2, I installed a battery pack and retested the ECM just to

verify I was testing with the correct voltage. While retesting, I captured the identical meter and scope readings, with one difference: the DTC P1636 was gone.

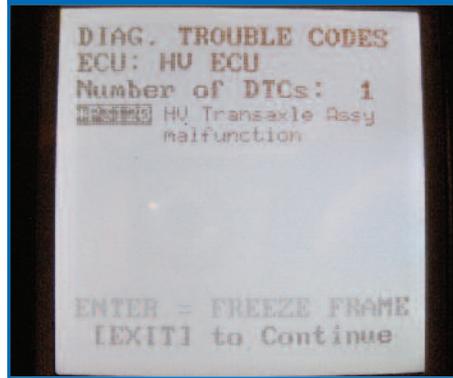
Figure 3: DTC P3120 HV Transaxle Assy Malfunction

DTC P3002 (HV Serial Communication Abnormality) deals with a communication problem to the HV ECU. This DTC was coming back even with the 12-volt AGM battery fully charged. I knew this vehicle now had a hard problem in the HV system but I proceeded to check the other DTCs. P3120 (HV Transaxle Assembly Malfunction) (Figure 3) confirmed the DTC HV P3002, but I had to look into the sub system DTC 253 Generator Resolver Inter-Phase Short. The sub system DTC lead me to the cause of my HV problem. The MG had a shorted winding that I confirmed with my megohm meter (Figure 4 - Bad & Figure 5 - Good.)

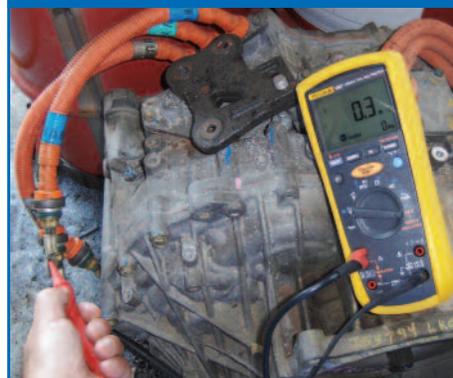
Figure 4: Hybrid transaxle with shorted MG windings

I was confident with my diagnosis and recommended replacing the salvage yard transaxle. We waited three weeks for the salvage yard to locate a replacement. When it arrived, we made sure to check the unit for visible damage and/or shorted windings. The transaxle was replaced for the second time, test driven and checked for DTCs, all without any problems. The Prius was ready to be returned to the customer, minus the Triangle of Doom. **WELLS**

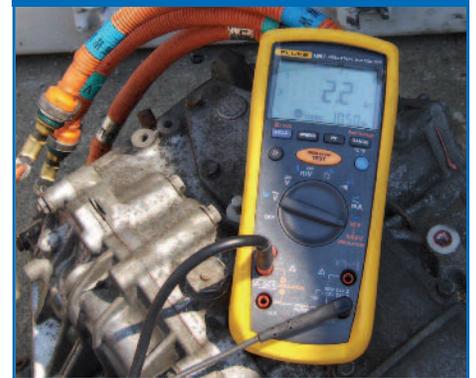
Figure 5: Second transaxle with good MG windings
