Misfire Diagnosis Case Study

Our case study concerns a 2003 Chevy pickup truck with a 6.0L engine (VIN U) and a coil-near-plug ignition system. The customer complained of a misfire and surging. Diagnostic trouble codes (DTCs) P0300, P0351 and P0357 were retrieved. All are misfire-related.

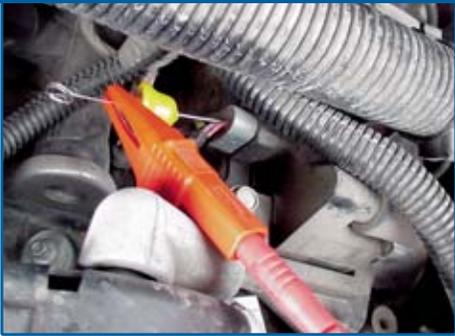
The second step in the diagnosis was to scope the #1 and #7 trigger signals with the harness connectors removed from the coil/module assemblies. This test would eliminate the coils as a possible source of excessive circuit loading. The expected voltage signal is a 0-5 volt square wave. To establish a baseline, the test was first used on the known-good cylinder coils for trigger signals. The six known-good trigger signals had a “high” voltage of 5.0 volts. Both the #1 and #7 trigger signals had a “high” voltage of only 4.75 volts.

A backprobe allows you to tap into the wiring between the PCM and the coil, without causing damage. Brace the alligator clip to avoid accidental shorts.

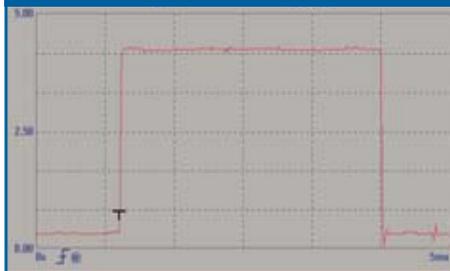
A scope was used to monitor the trigger signals from the PCM to the #1 and #7 coils with the engine running. Once captured, they were compared to the six known-good trigger signals from the PCM to the other coils. The trigger signals produce a simple square wave when viewed on a scope. The six known-good trigger signals had a "high" voltage of 4.25 volts at the top of the square wave. The #1 and #7 trigger signals had a "high" voltage of only 4.0 volts.

The P0351 and P0357 DTCs appeared to be legitimate. There was a 0.25 volt difference between the good trigger signals and the two suspect trigger signals. Could the two new replacement coil/module assemblies be excessively loading the trigger signals supplied by the PCM?

This screen capture reveals a normal square wave control signal from the PCM to the coil primary. Our defective signal was only .25 volt below normal.

The fourth step was to measure resistance between the open #1 trigger wire and ground. Resistance was observed. Resistance was also observed between the #7 trigger wire (disconnected PCM connector) and ground. Resistance was also measured between the #1 and #7 trigger wires, and between both wires and ground, was due to moisture in the PCM harness. Moisture had entered the PCM harness, attacked the copper wire and created a high resistance. This was enough to load the circuit by 0.25 volts and the difference was enough to flag the P0351 and P0357. After a wire and harness repair, this vehicle was fixed.
