# WELLS Counter Point

Volume 2 Issue 1, February 1998

## TPS Knowledge is Power

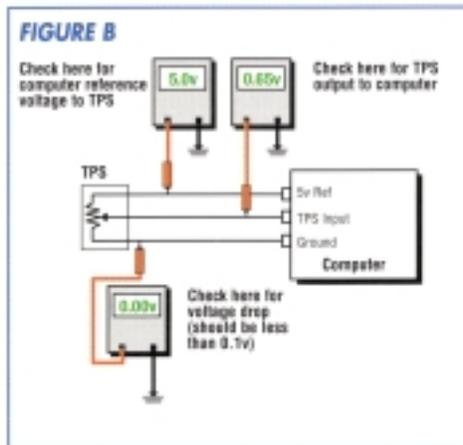
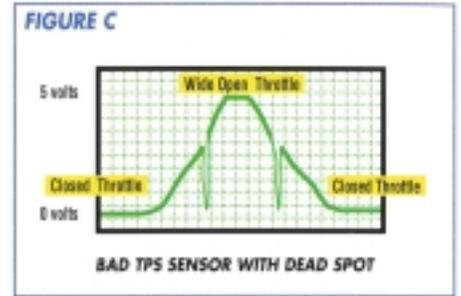
Erratic readings or momentary infinity (open) readings indicate a defective sensor. (See figures B and C) Full continuity (zero ohms) in either position would indicate a shorted sensor.

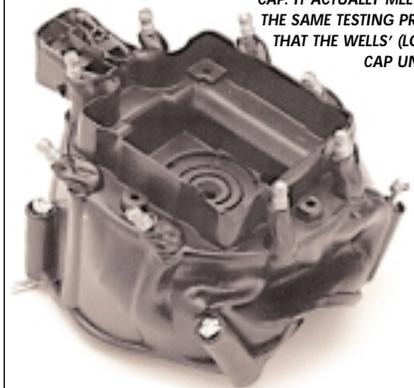
We found a competitor's cap that is made of materials that do not meet OEM specifications. The cap is for a popular GM application which requires a high temperature material such as "PBT" (polybutylene terephthalate). But this cap is made of "PP"

(polypropylene), which has a much lower melting temperature (350 degrees F vs. 482 degrees F for PBT). Though PP is often used for OEM distributor caps in other applications, it is not a suitable material for this particular application because it could fail under high-temperature operating conditions. It actually melted when subjected to the testing procedures that caps made by WELLS undergo, as the photo accompanying this article shown.

THIS IS A COMPETITOR'S DISTRIBUTOR CAP. IT ACTUALLY MELTED UNDER THE SAME TESTING PROCEDURES THAT THE WELLS' (LOWER LEFT) CAP UNDERWENT.

PBT, not PP. Consequently, because of differences in shrinkage rates, this cap had a slightly smaller inside diameter creating potential installation problems.

Our cap for this application is made out of an even better material that exceeds the OEM cap requirements: a blend of PBT and PET (polyethylene terephthalate). This material has an even higher melting point (500 degrees F) and also provides increased stiffness and resistance to warpage. That's the quality difference you'll find with WELLS products.
