WELLS Counter Point

Volume 4 Issue 1, January 2000

Idle-Speed Controls

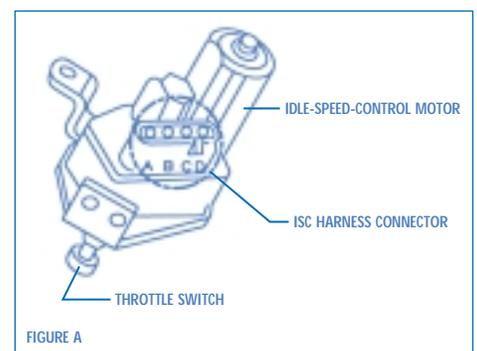
FIGURE A

Grounding terminal "D" on the back of the ISC motor and applying battery voltage to terminal "C" should cause the plunger to fully retract (See Figure A). Reversing the connections (grounding "C" and supplying voltage to "D") should run the plunger all the way out. If nothing happens when you jump the ISC motor, the motor is defective and needs to be replaced. But if it works, the problem is in the wiring or ECM.

Do not jump the ISC motor after the plunger reaches the fully-extended or retracted position

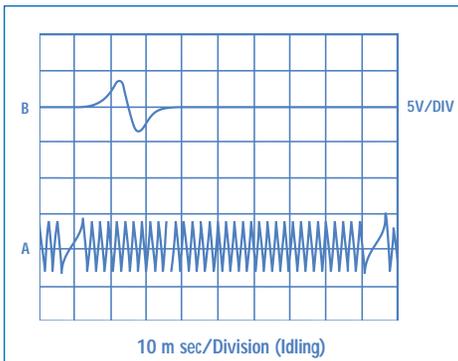
Q: "I have a 1995 Toyota Tercel that bucks and jerks under load at higher RPMs. Pulled codes and got a knock-sensor code. Replaced sensor and no more code but still have the same bucking and jerking problem. When it bucks, it loses spark and injector pulse. Everything checks out okay with the scanner on it while driving. This thing is giving me a headache and whiplash! Any ideas would be greatly appreciated."

An intermittent crankshaft position signal may be causing the problem. In addition to the sensor itself, loose or corroded connectors or wiring could be the cause. The scope patterns shown below for the crankshaft position sensor (A) and the camshaft position sensor (B) are typical. Lightly tap on the sensor and wiggle the wiring harness and connectors while looking for an interruption in the signal.

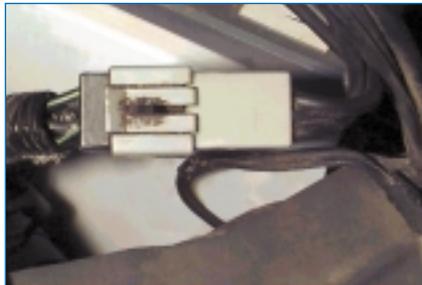
Q: "I have a 1996 Ford Taurus 3.8L that will not start. There is spark, fuel pressure and injector pulse. But the strange thing is that it has all these things while the ignition switch is in the on position and the engine is not even being cranked! When this happens, the fuel injectors click, the ignition coil buzzes and so does the integrated-relay-control module (IRCM). I have replaced the ignition-control module but that didn't change anything. When I unplug the control-module harness connector, the coil stops buzzing but the injectors and the IRCM still do their thing. Have you ever heard of this kind of thing before?"

Actually Mike, I have seen this before. In each case, the problem turned out to be a bad ground connector located near the battery and was accompanied by a buzzing IRCM and clicking injectors. Repair of this connector and the associated ground connections will solve the problem.

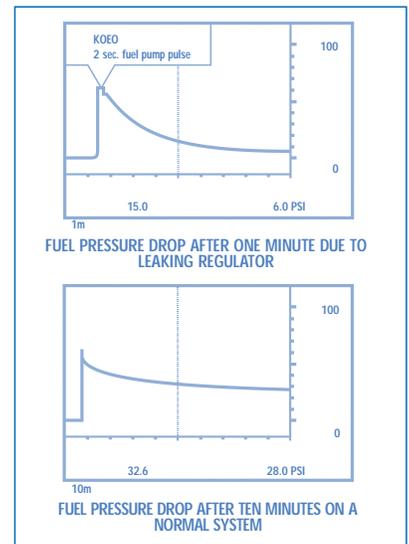
Q: "I have a 1995 S10 Blazer with the 4.3L Vortec engine that has idle and acceleration problems. This engine only runs rich on one side, the even bank. This shows up in the secondary ignition pattern and on a cylinder balance test. Everything else looks Okay, but since this is a Vortec system, I'm not sure how the fuel injection assembly could only affect one bank of cylinders. Any thoughts on this?"

In cases like this, it is common for a leak to occur in the housing that holds the fuel injector and pressure regulator. Depending on where the leak is, it can affect one side of the engine more than the other. Since all of the plumbing is inside the intake plenum, a fuel-pressure leak-down test would be one way to verify a leak. After running the engine (or just the fuel pump) and shutting it off, the fuel pressure should hold for quite a long time. If there is a leak, the pressure will drop off immediately.

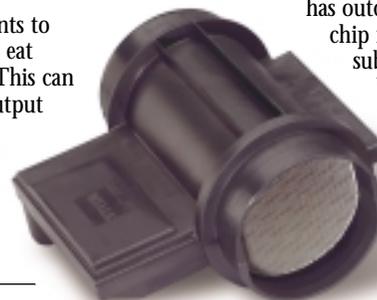
WELLS has developed design improvements for 10 mass airflow (MAF) sensors for 1985 to 1989 General Motors applications that eliminate the most common cause of sensor failure on these vehicles: circuitry contamination.

The troublesome OEM MAF sensors on these vehicles have their main circuit board mounted in the airstream. This provides additional

cooling, but also exposes the components to environmental contamination that will eat through the protective epoxy coating. This can result in declining accuracy of MAF output signals and outright sensor failure.

The OEM sensor, by comparison, has outdated wire bonding and chip resistors on separate substrates. That's why WELLS MAF sensors outlast and outperform the OEM sensors.

In the redesigned WELLS MAF sensor, the electronics are relocated out of harm's way. The main circuitry

is safely mounted on a substrate adhered to an aluminum heat-sinking plate, sealed inside an environment-proof housing. The only components exposed to the airstream are the heater element and thermistor. In addition, WELLS also uses a more rugged and compact circuit design with fewer interconnections.

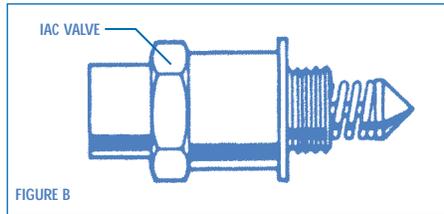
The IAC valve opens a small bypass circuit that allows air to flow around the throttle. Increasing the volume of air that's allowed to bypass the throttle increases idle speed, while reducing the bypass airflow decreases idle speed (See Figure B).

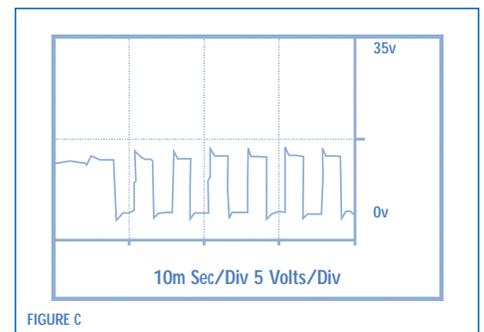
Digital Storage Oscilloscope (DSOs) can also be used to view IAC wave forms. A typical GM is illustrated above (Figure C).
