Editor's Notes

More On Distributor Components

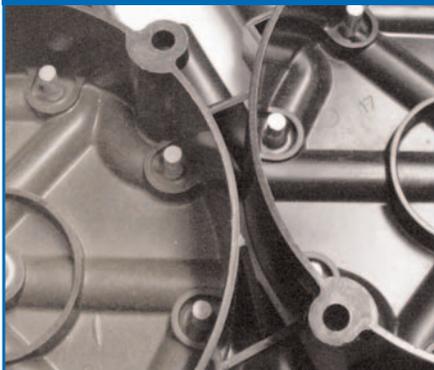
In this issue's "Fine Tuning," we helped a reader who was having no-start problems on a customer's car. The cause of the problem turned out to be a blocked distributor vent, which was causing an abnormally high level of ozone buildup inside the distributor. We included a photo of the vent, but not the discolored secondary ignition components (cap and rotor) which often result when a distributor vent is clogged.

Clogged distributor vents may cause an abnormal ozone buildup inside the distributor. Discolored components (left) are a possible tip-off to venting problems.

Examine the sample photos on this page. Each includes a good ignition component, next to a used component that has been discolored by high ozone levels inside the distributor. Keep an eye on those distributor vents during ignition maintenance work!

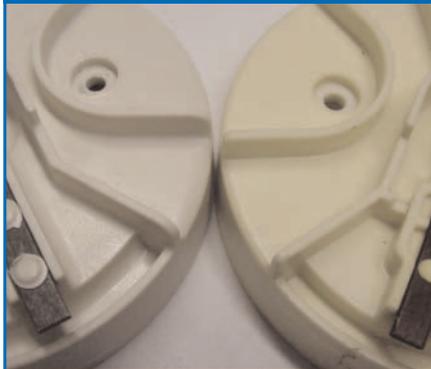
We expect to see some discoloration as secondary ignition components age in service. However, higher than normal discoloration (left) may indicate distributor venting problems.

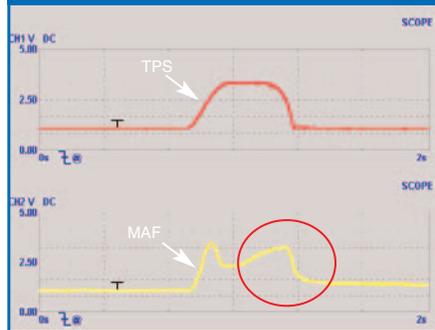
Comparing the TPS and MAF oscilloscope traces is a very effective means of determining the health and responsiveness of the MAF.

Ford MAF and TPS oscilloscope patterns (both good).

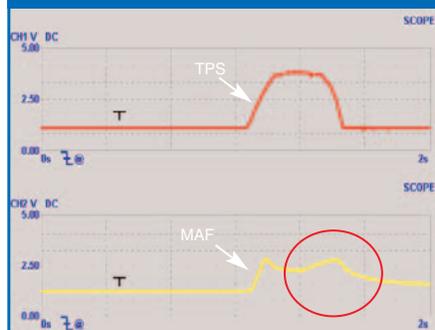
Ford MAF and TPS patterns (bad MAF pattern). Notice how the second wave of voltage has decreased and the drop off voltage back to ground is shallower.

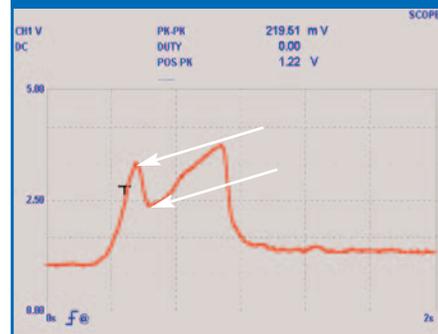
A good Ford MAF pattern. A voltage drop between the two arrow points is normal.

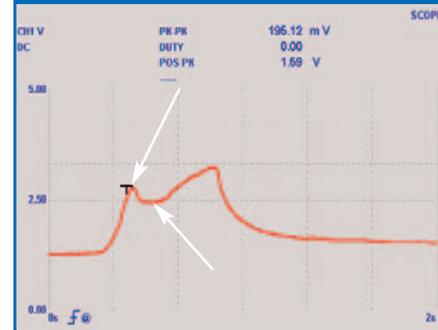
The wiggle in the MAF signal between the arrow points is normal. The sensor is very sensitive to incoming air. What we're seeing is normal intake air from cylinder efficiency. A good sensor will produce at least 4 volts on a wide open throttle snap. A bad sensor will have high voltage at KOEO and won't reach 4 volts during a snap throttle test. Set your oscilloscope on the 500 ms scale for best viewing. Notice the difference in the KOEO voltage between good and bad — 1.22 V versus 1.59 V at idle.
