Misfire Diagnosis Case Study

Our case study concerns a 2003 Chevy pickup truck with a 6.0L engine (VIN U) and a coil-near-plug ignition system. The customer complained of a misfire and surging. Diagnostic trouble codes (DTCs) P0300, P0351 and P0357 were retrieved. All are misfire-related.

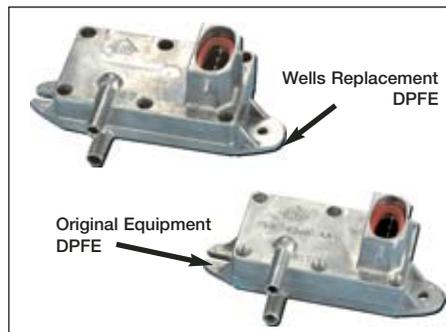
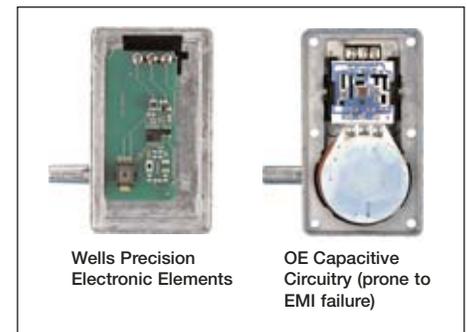
The original equipment (OE) DPFE sensor functions by exposing a pressure sensor to the exhaust gasses. These gasses are harmful to the sensor's gasket and diaphragm, which can result in premature sensor failure. The OE sensor is

also vulnerable to electromagnetic interference (EMI), due to its capacitive circuitry.

The first step in the Wells solution to these shortcomings is a precision electronic element that is highly resistant to EMI. Next, we incorporate a small but very accurate pressure sensor. To visualize how it works, imagine a bass drum. EGR pressure presses on the outside of the drum skin. The pressure sensor on the opposite side of the drum skin very accurately

reads the changes in EGR pressure. The outside of the skin is exposed to exhaust gases, but the Wells sensor is treated with a special silicone coating that will virtually never deteriorate. The differences in the internal DPFE technology are shown here and on the “Editor's Notes” page at www.wellsmfgcorp.com. These improvements lead to greater sensor accuracy and longevity.
